Section 319 NMP Projects:

Do BMPs Really Work?

Morro Bay NMP: a ten-year study and selected project highlights

project conducted by the
Central Coast Regional Water Quality Control Board and
California Polytechnic State University San Luis Obispo
in cooperation with the

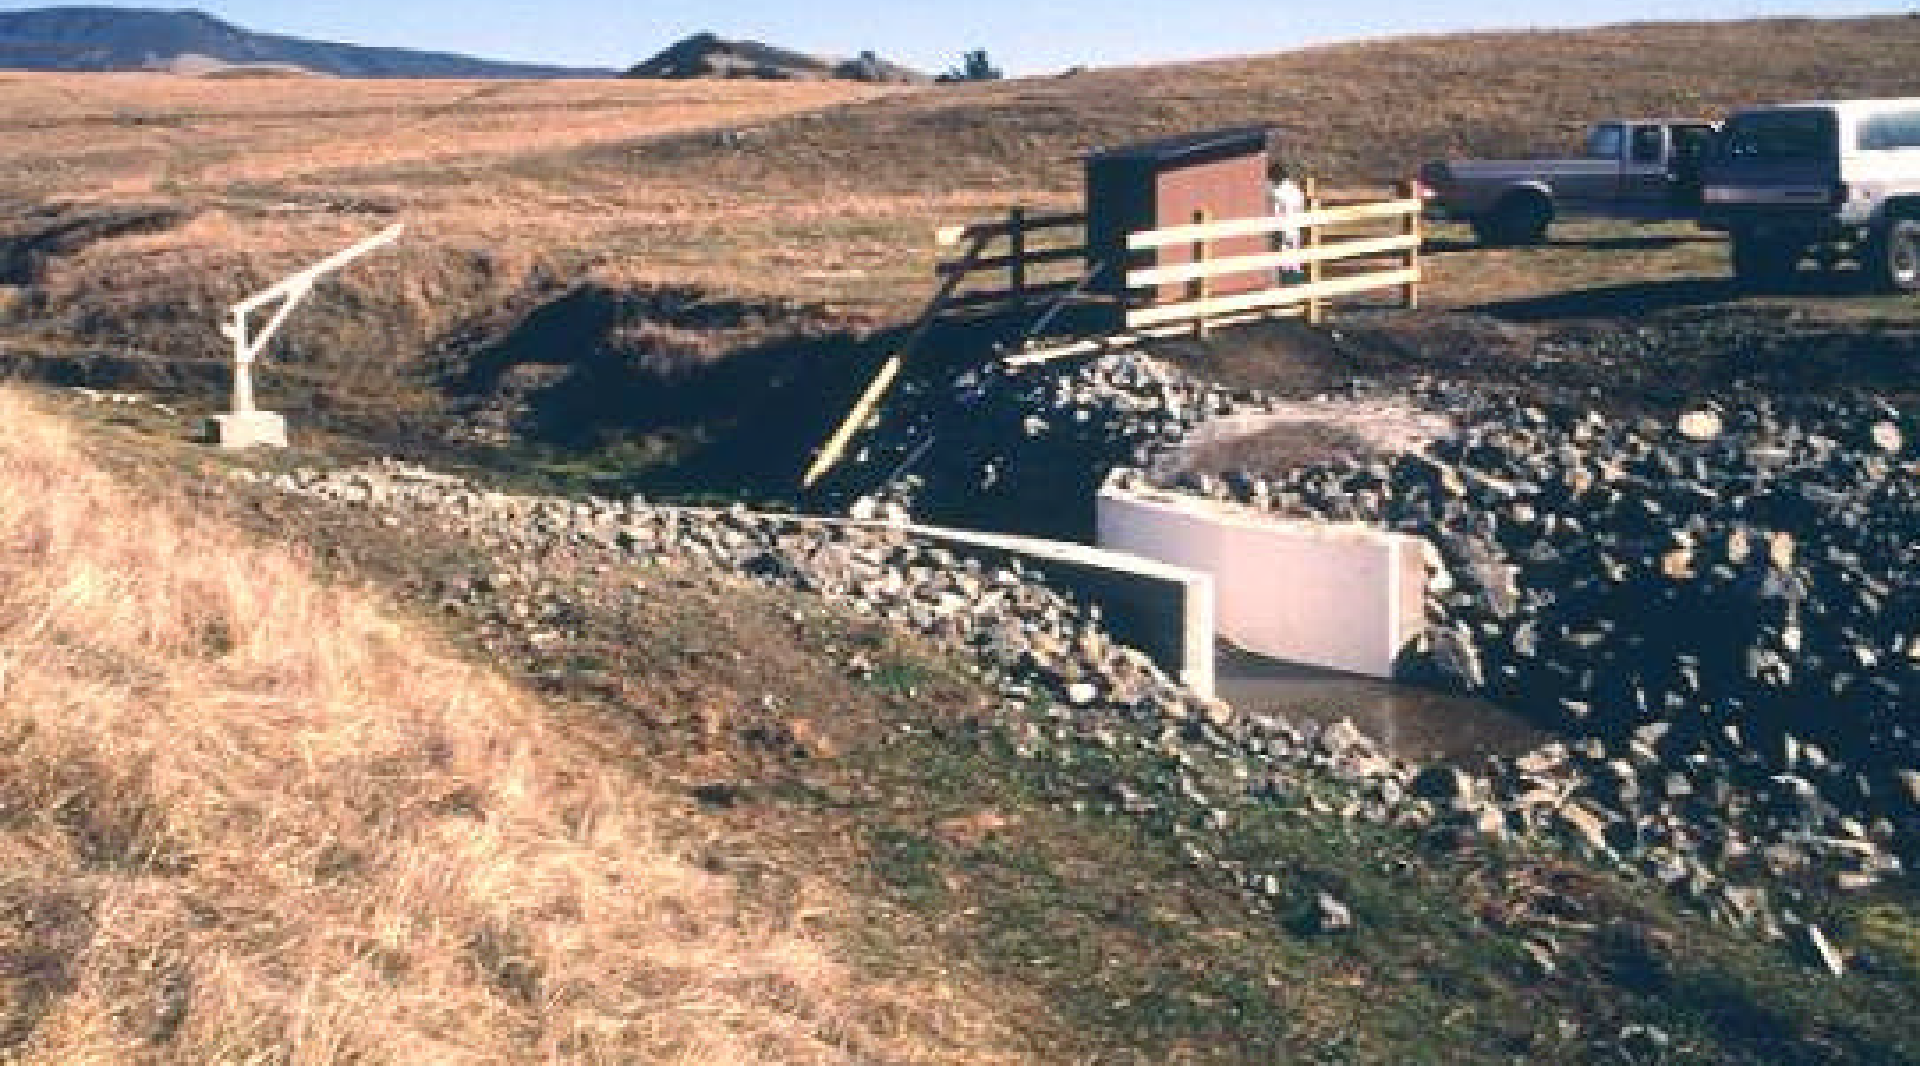
Paired Watershed Study Design

Walters (control)

Chumash (treatment)

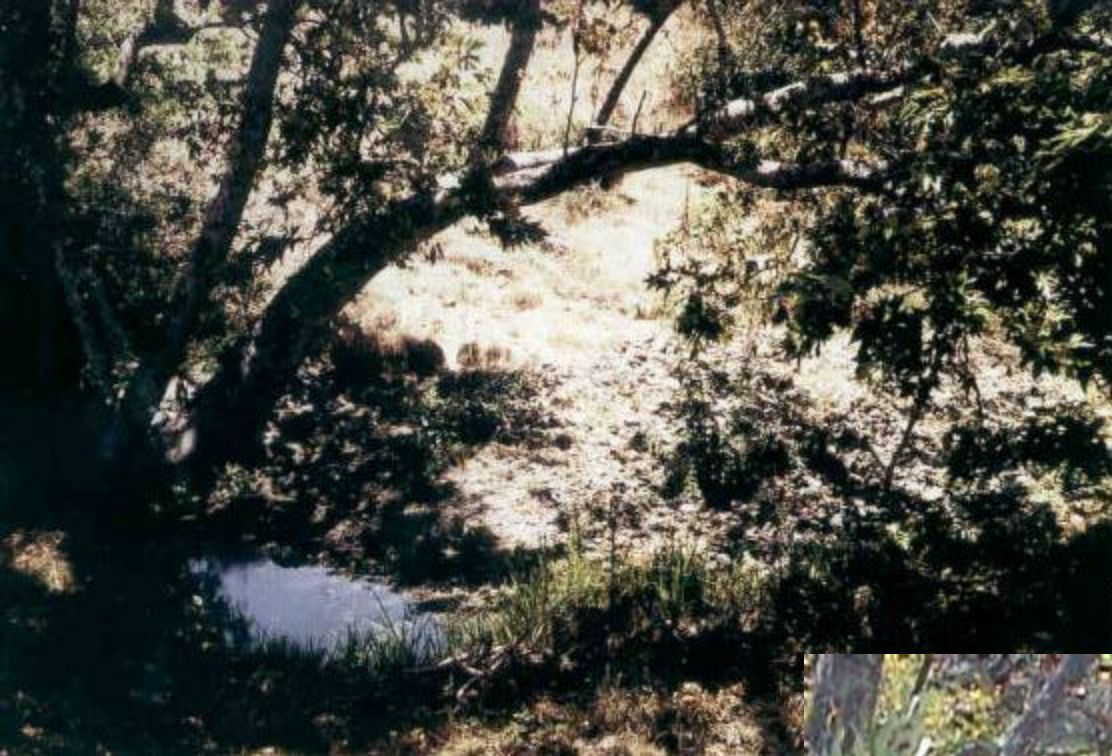
Pre-BMP period

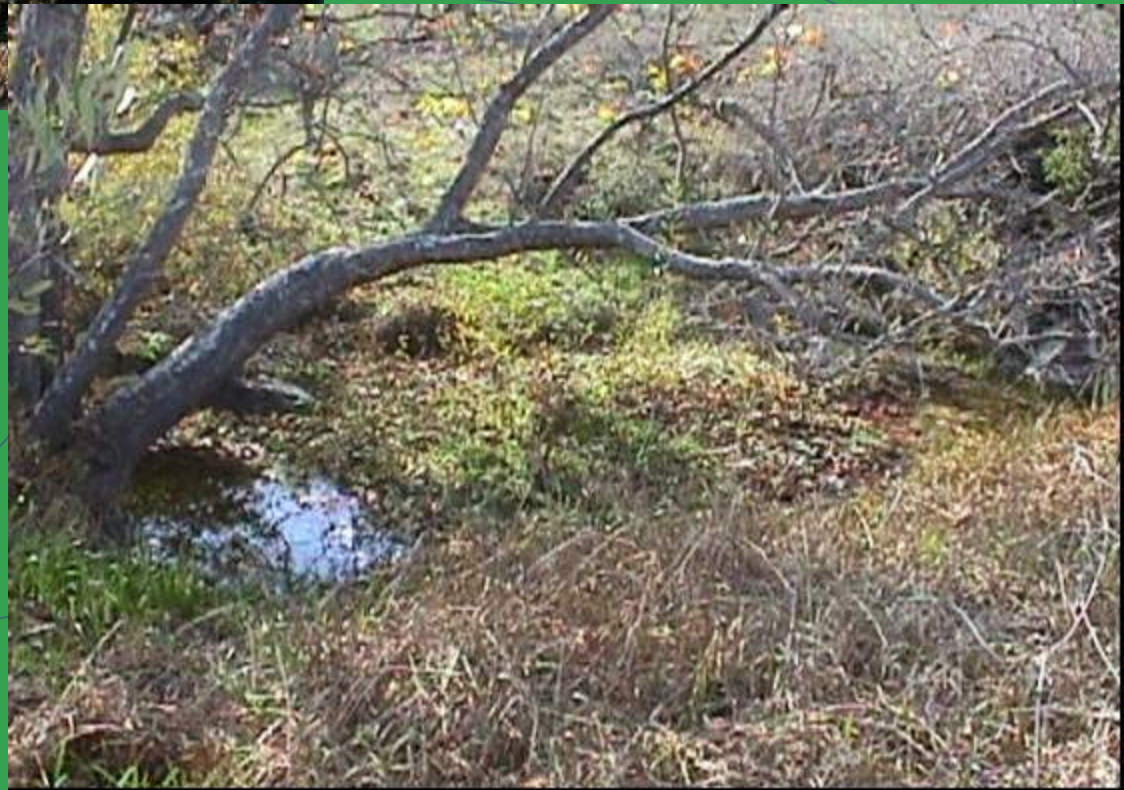
Post-BMP period

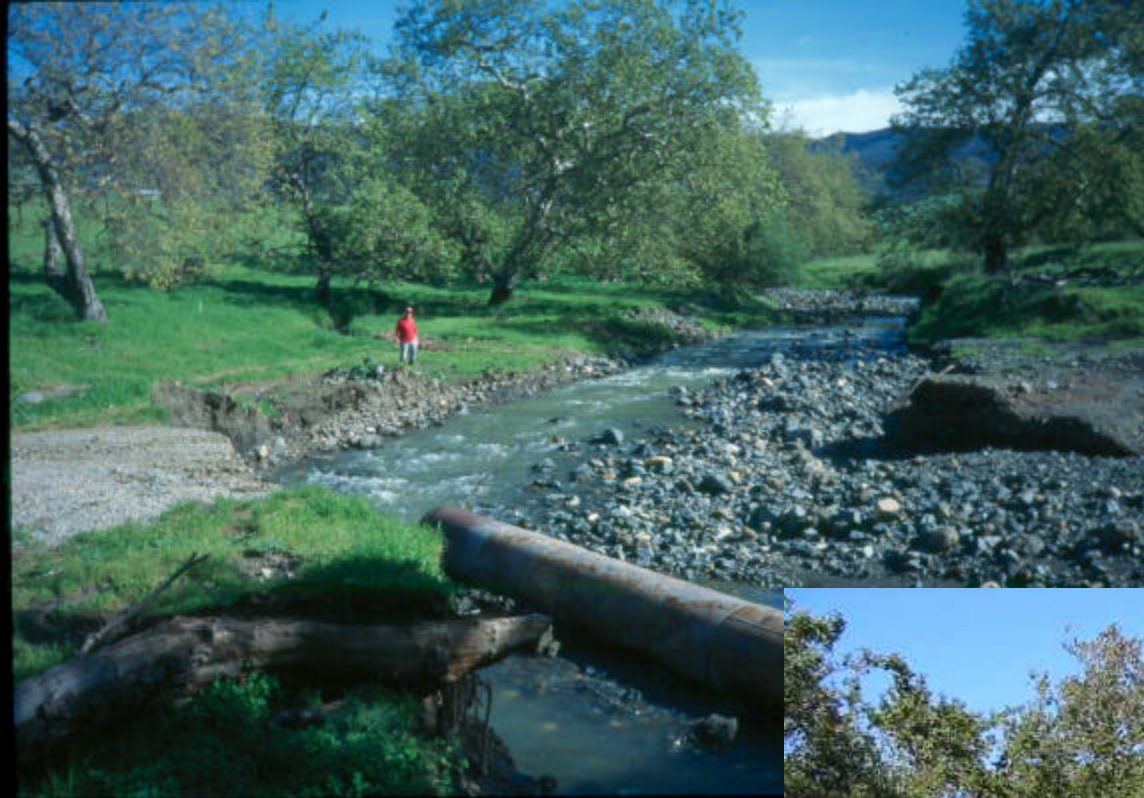
Pre-BMP period

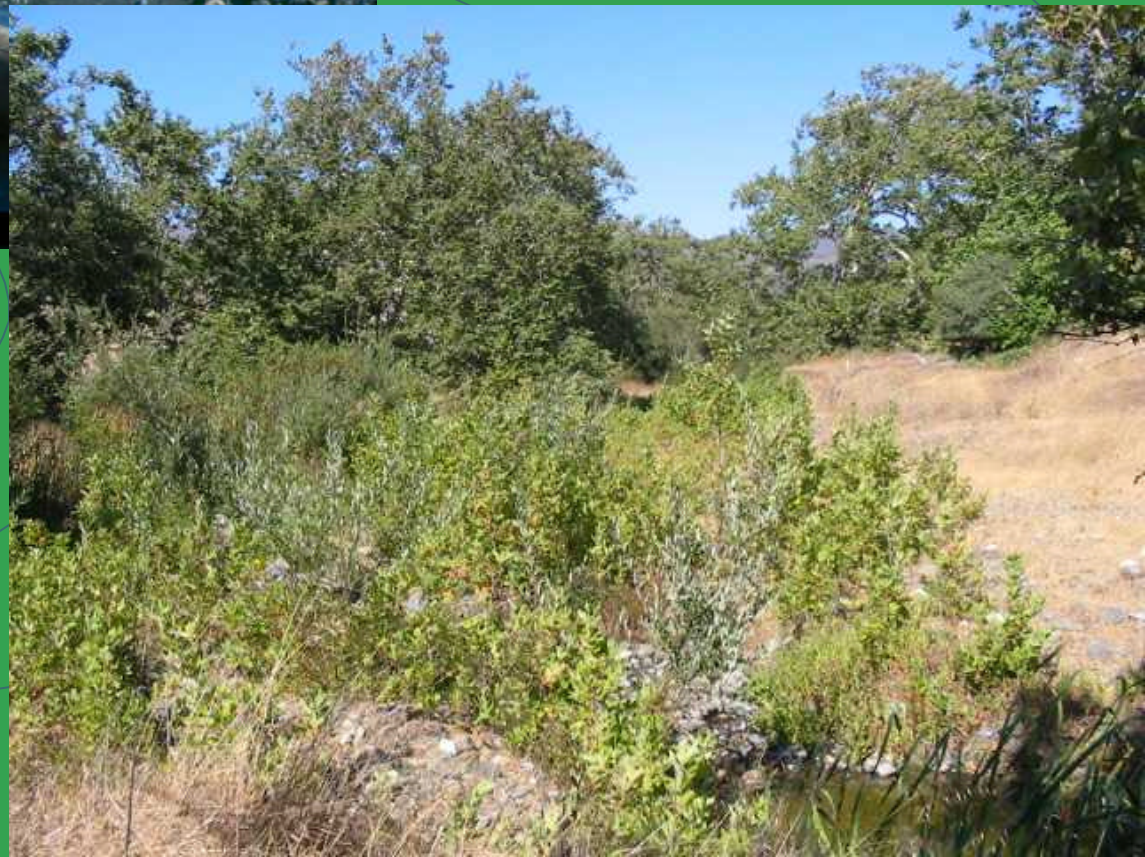
Post-BMP period

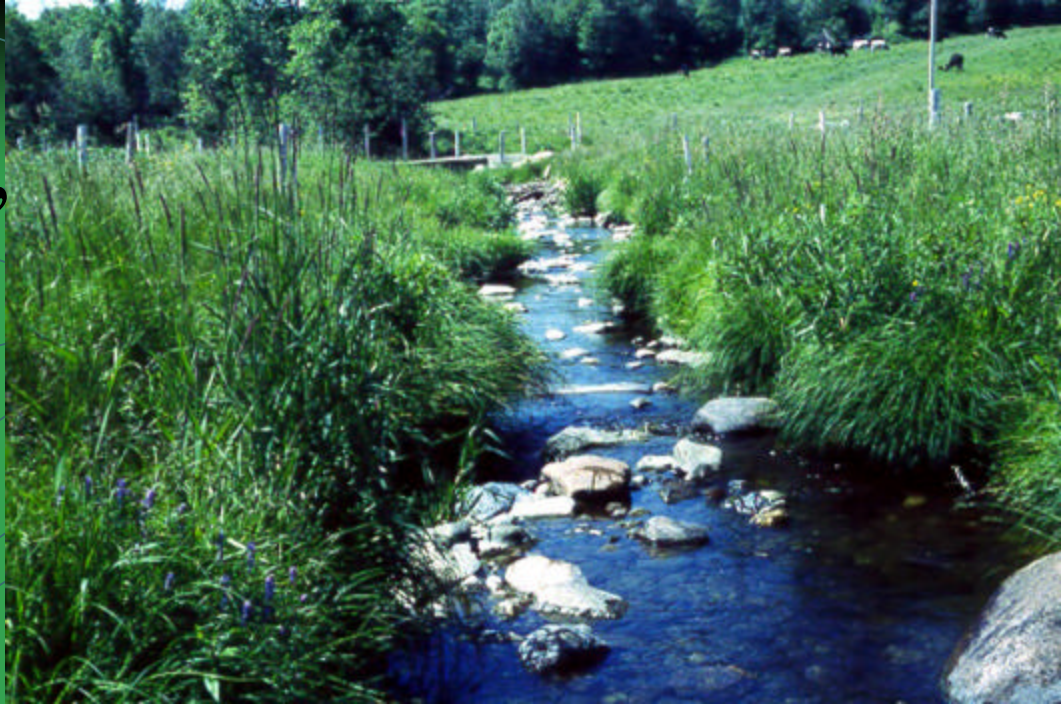
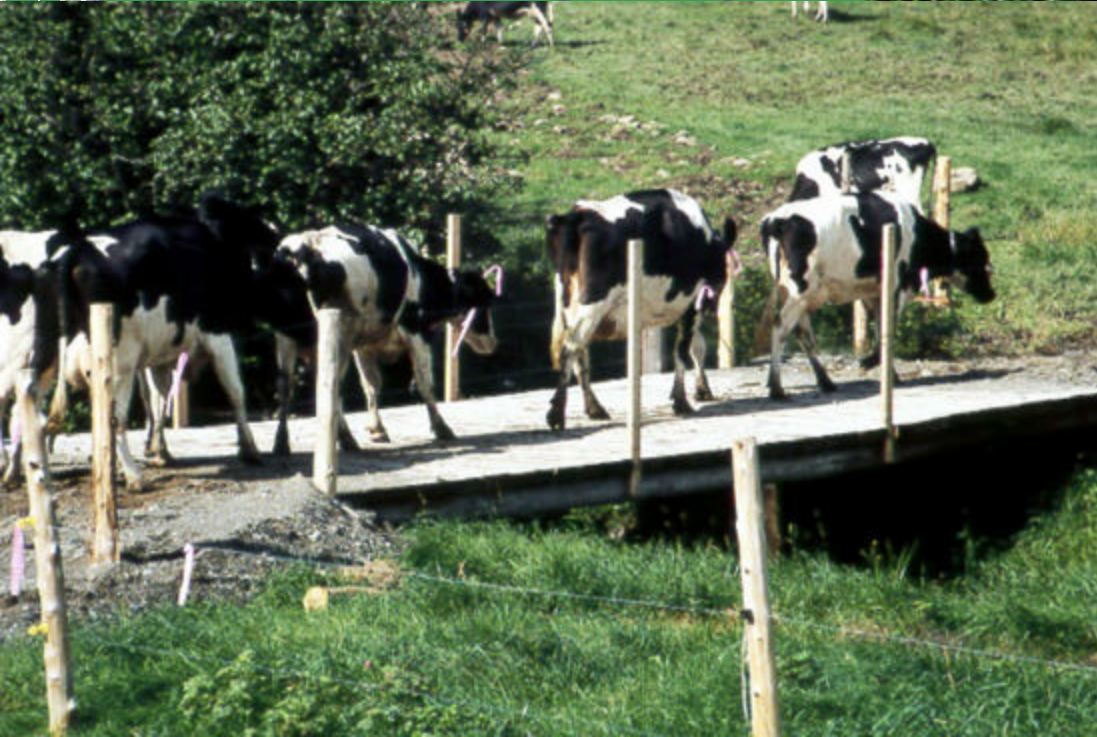
Lake Champlain, Vermont

Improved
Total Phosphorous
and
Bacteria

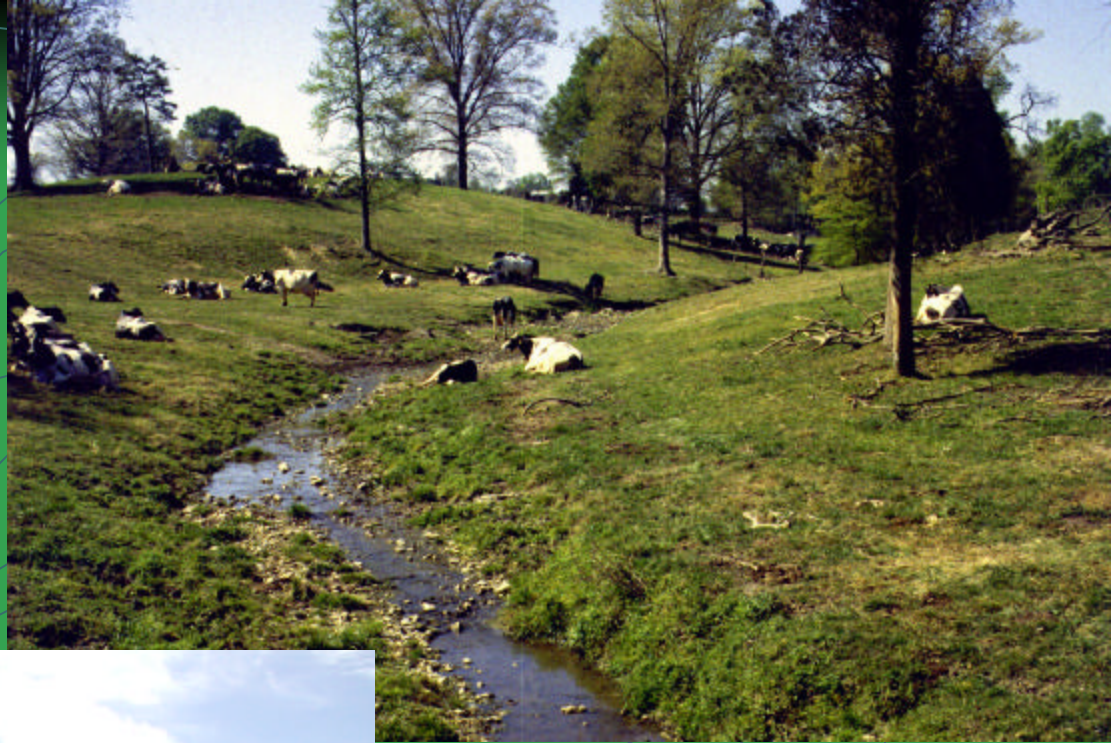
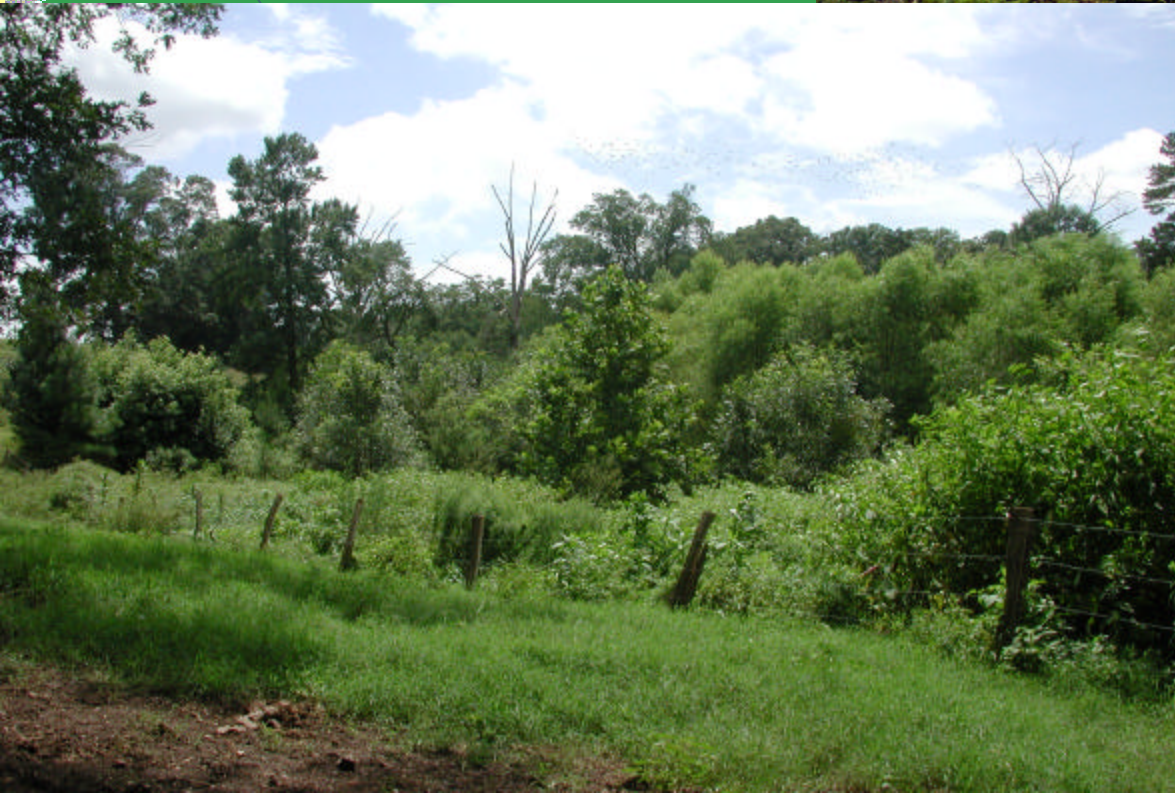
Long Creek, North Carolina

Improved Turbidity,
Sediment,
Fecal Coliform, and
Total Phosphorous

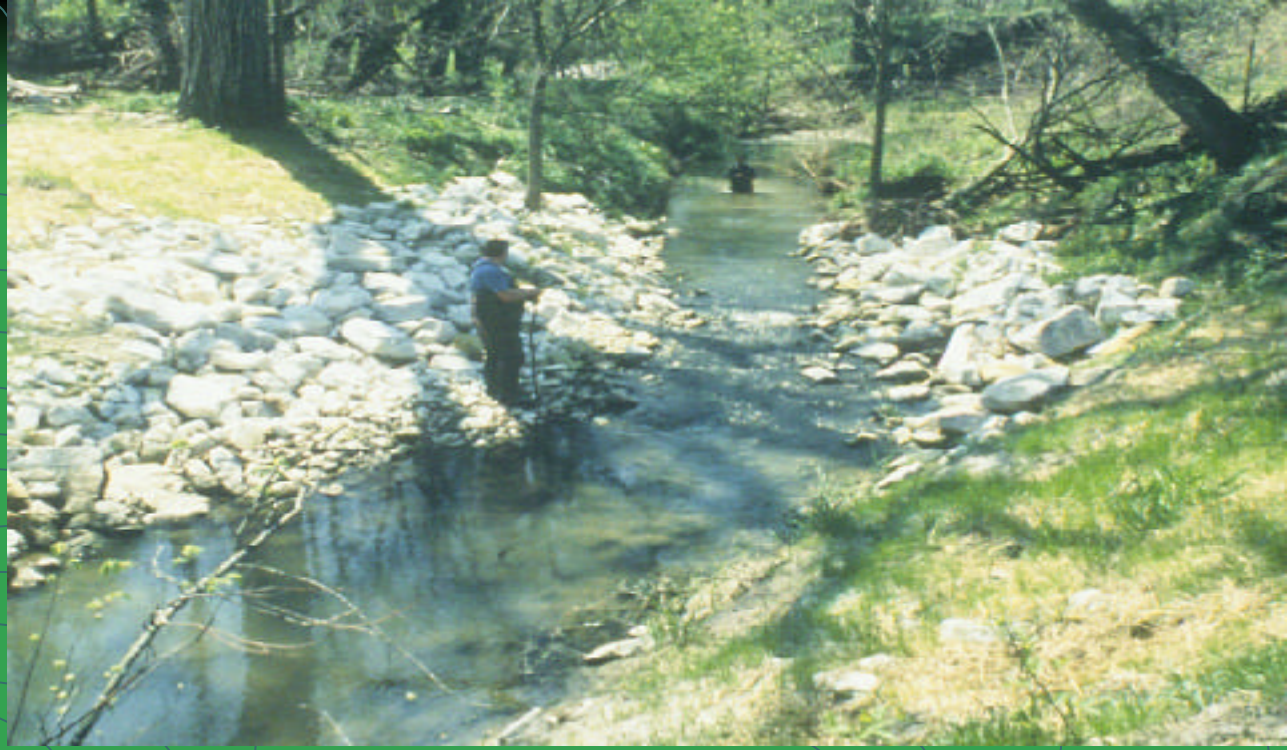
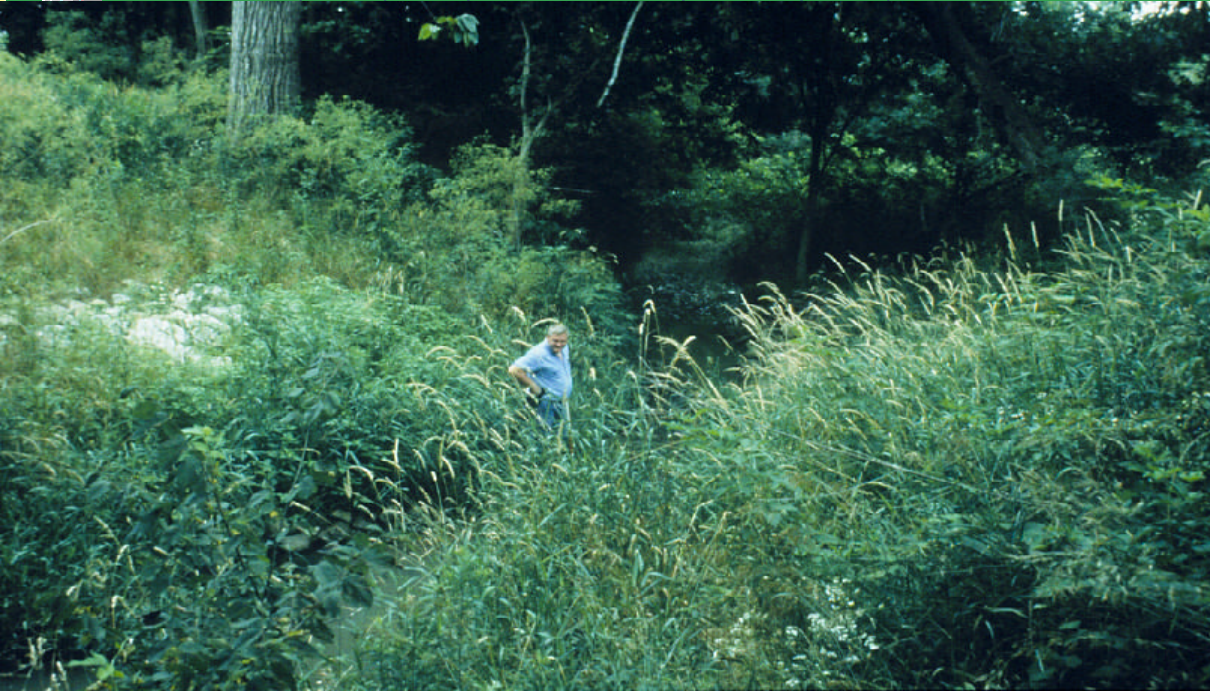
Lake Pittsfield, Illinois

Improved
Sediment loading
